## Coxmate Impeller (SX-Imp-xxx) Speed Sensor

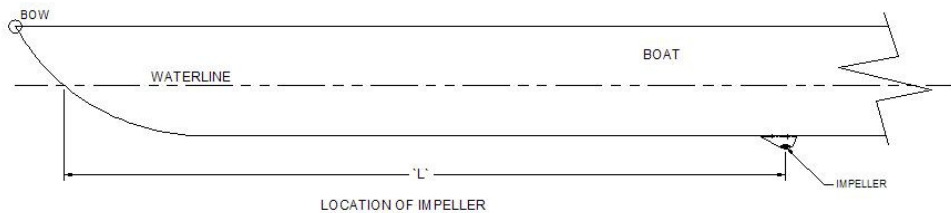
The nominal calibration figure supplied with sensor is  $K=1.000$ . However as this is only a nominal calibration, and in boat calibration is required for high accuracy- the SX has inbuilt GPS, which facilitates this. It is important to mount the speed sensor as far forward as possible. As the sensor gets further from the bow, so does the degree of turbulent noise. This noise appears on the instantaneous speed curve, and reduces it's value for analysis. Practical access restrictions may limit how close to the bow the sensor is mounted. If access was not a problem then distance  $L=$  between 1 and 1.5 metres would be optimal. If you do not want to use the 'stroke profile analysis', i.e. the variation of speed through the stroke, features of the software, then the impeller can be mounted further astern. In this case, all other functions will still operate.

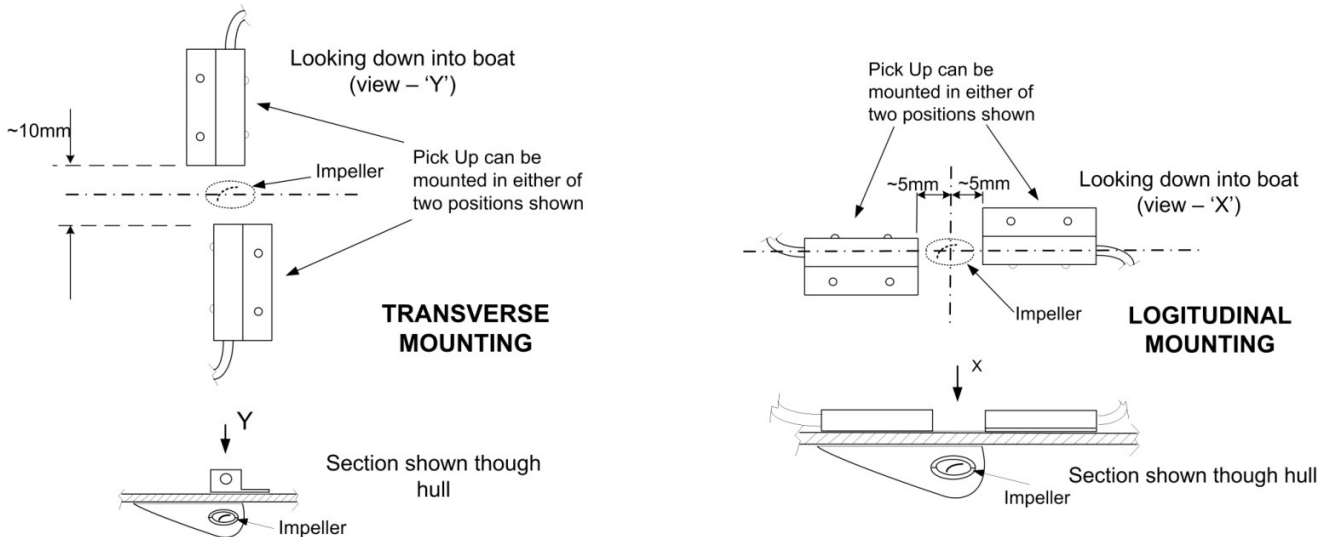
The mounting of the speed sensor impeller and pick up is shown in following diagram. Four mounting arrangements are shown. To assist in positioning the sensor in respect to the impeller, two magnets (approx 3 x 6mm diameter) are included. Place one magnet on inside of hull and one on outside of hull.

The alignment of the impeller fin is critical – it must be in line with the hull. It is helpful to use a long straight edge to align fin. It is generally recommended for the fin to be mounted at or within ~100mm from the centreline of the hull on a scull/double and up to 200mm for a four/eight.
